Manhole Inspection Summary

Manhole # S47CC_023MH

Insp Date: 1/31/08 2:56 PM

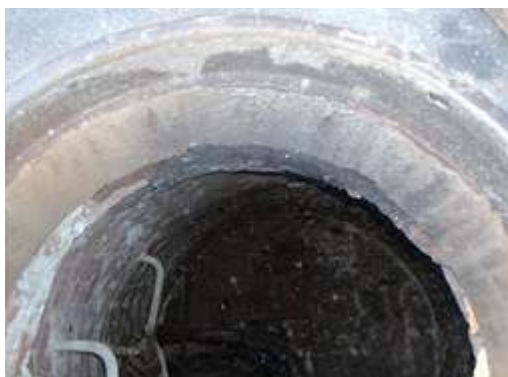
Defect 1

Frame Offset: **6** (in.) Condition: ☐ Sound ☐ Cracked ☒ **Leaks**

Infiltration: ☐ None ☒ **Joint** ☐ Cracks ☐ Mortar ☐ Roots ☐ Wall

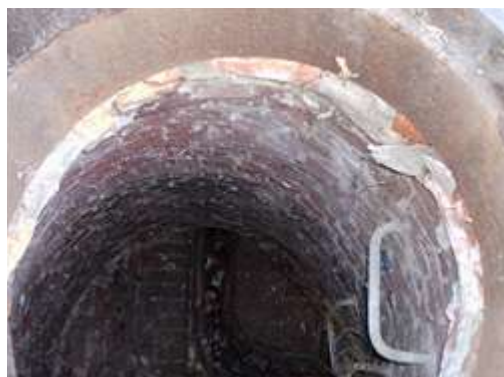
Defect 2

Steps Count: **3** Missing: **0** ☒ **Corroded**

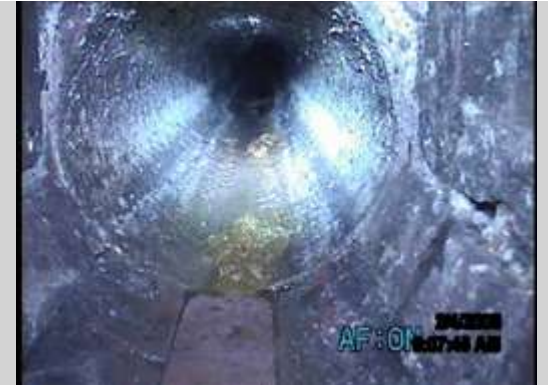
12 O'Clock Outflow

8 in. Circular Gravity Sewer
Pipe Out @ 12 O'Clock

Pipe Height: **8.4** (in.) Rod and Bar (Angled)
Pipe Material: **Clay** ☐ Pipe Lined
Invert Depth: **7.80** (ft.) Flow Characteristics: **Slow**
Deposits: ☒ None ☐ Mud ☐ Sludge ☐ Debris ☐ Grease
Silt Depth: (in.) Deposits Extent:
Infiltration: **None** Pipe Seal Cond: **Sound**

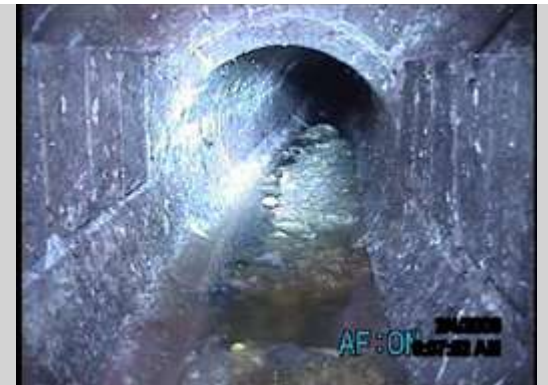
3 O'Clock Inflow

8 in. Circular Gravity Sewer
Pipe In @ 3 O'Clock

Pipe Height: **8.4** (in.) Rod and Bar (Angled)
Pipe Material: **Clay** ☐ Pipe Lined
Invert Depth: **7.65** (ft.) Flow Characteristics: **Slow**
Deposits: ☒ None ☐ Mud ☐ Sludge ☐ Debris ☐ Grease
Silt Depth: (in.) Deposits Extent:
Infiltration: **None** Pipe Seal Cond: **Sound**
